Manhole Inspection Summary

Manhole # S15C__032MH

Location Address: **2704 FRANKLIN ST**

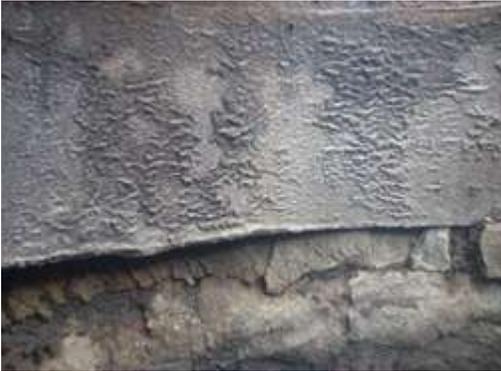
Defect 4

Chimney / Frame Adjustment Exists Material: **Brick and Concrete** Parged Height: **3** (in.)

Condition: Sound Cracked Root Intrusion Loose Brick **Deteriorated**

DETERIORATED CHIMNEY

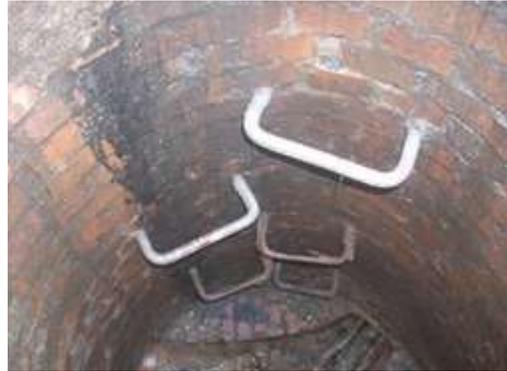
Defect 3

Steps Count: **5** Missing: **0** **Corroded**

CORRODED STEPS

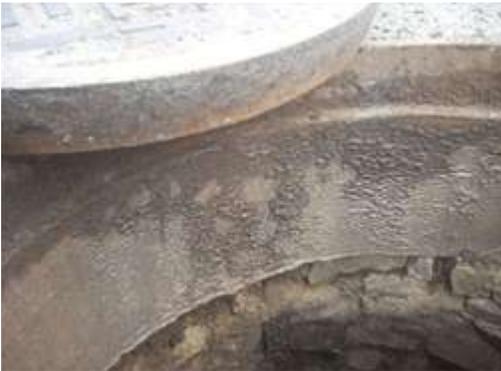
Defect 2

Infiltration: None Joint Cracks Mortar Roots **Wall**

INFILTRATION OF CORBEL WALL

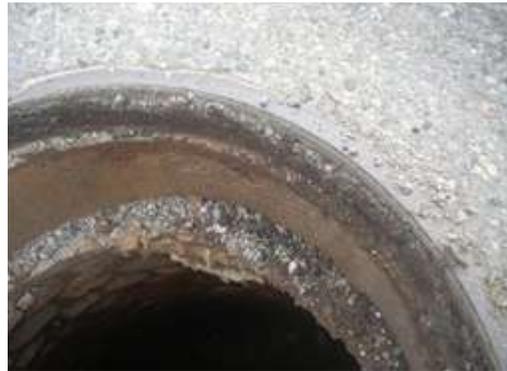
Defect 1

Frame Offset: **2** (in.)

FRAME OFFSET

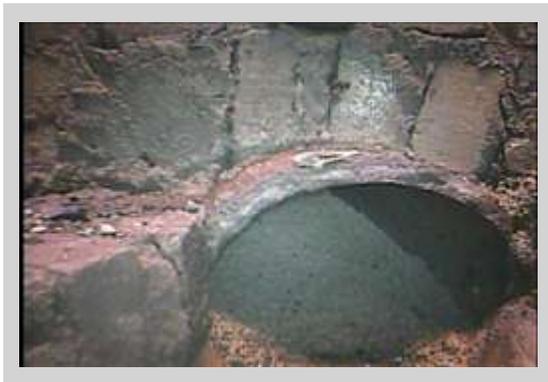
3 O'Clock Inflow

ADANDONED

Connects To: **Stub connection / abandoned**
 Possible Illicit Connection

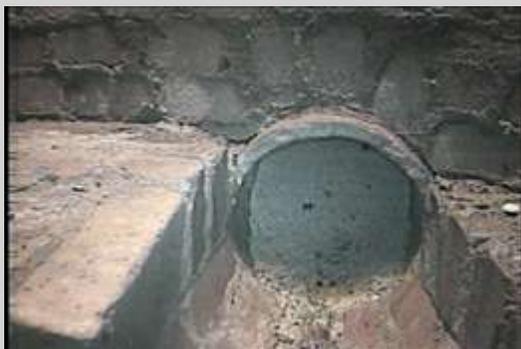
8 O'Clock Inflow

ABANDONED

Connects To: **Stub connection / abandoned**
